Lenovo IdeaPad U430 Touch Charging Port Replacement

This guide shows how to replace the Charging Port for a Lenovo IdeaPad U430 Touch. After a recall on the charging port, this became a common replacement.

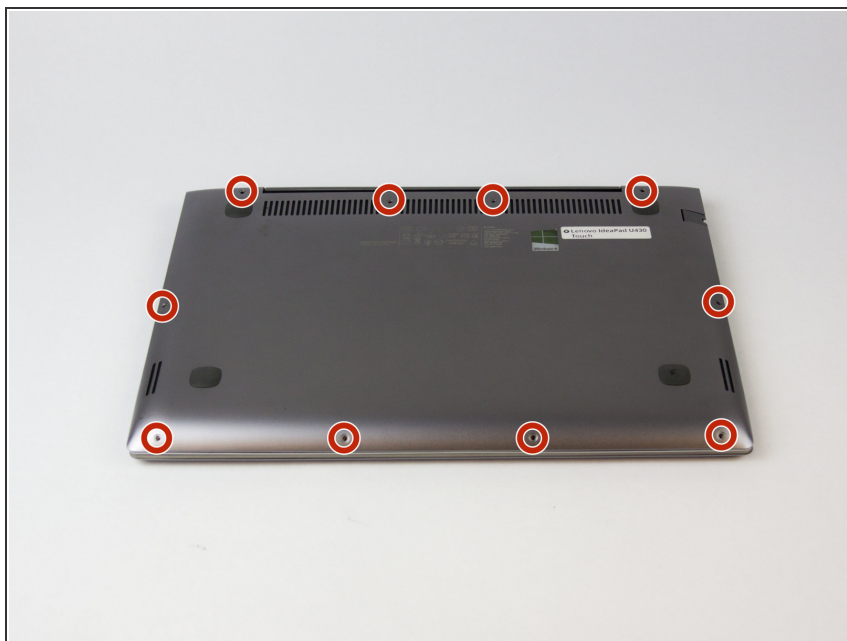
Step 1 — Bottom Cover

- It is important that you power off your laptop before you begin.
- Find and remove the 10 Phillips style body screws on the bottom of the laptop case.

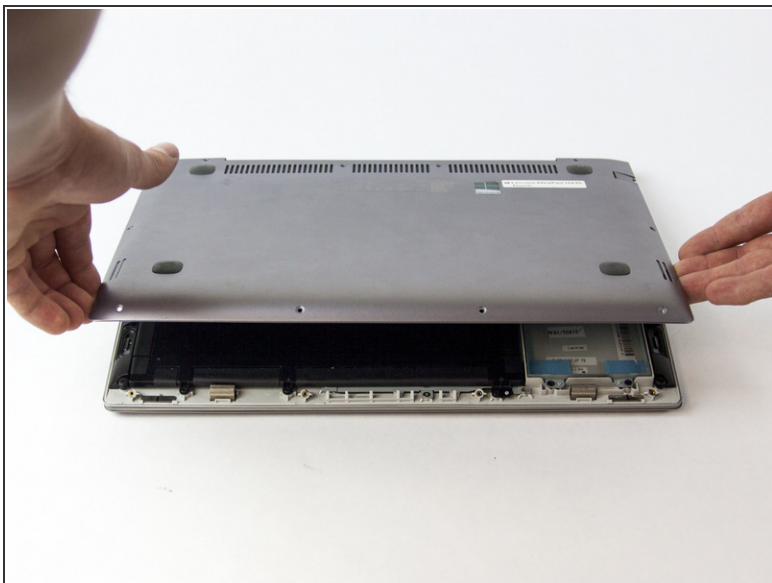
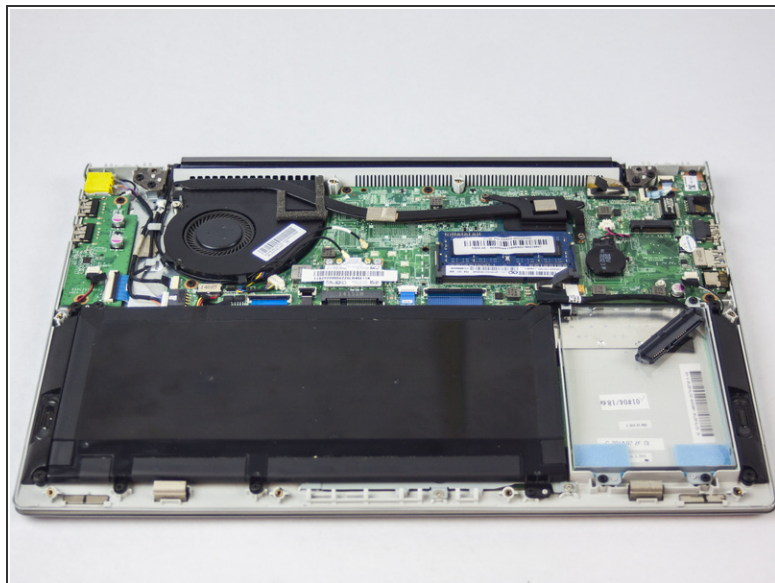
Step 3

- Starting from the front, use a plastic opening tool to separate the bottom of the case from the body of the laptop.

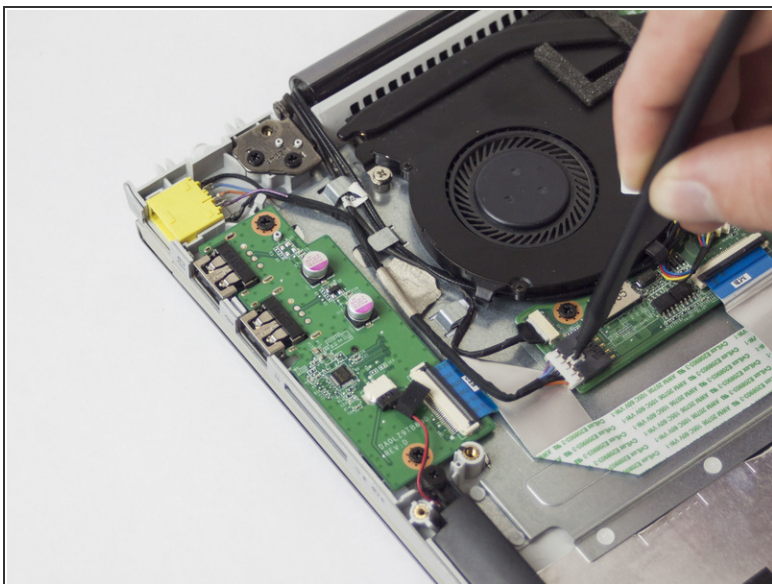
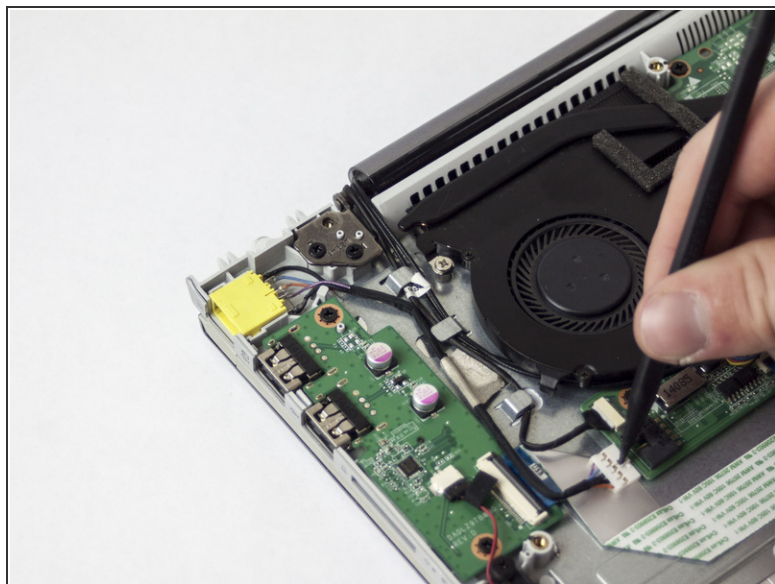
Step 4 — Charging Port

- Disconnect charging port from motherboard.
- To do this, press the spudger on the center dimple and push the connector out.

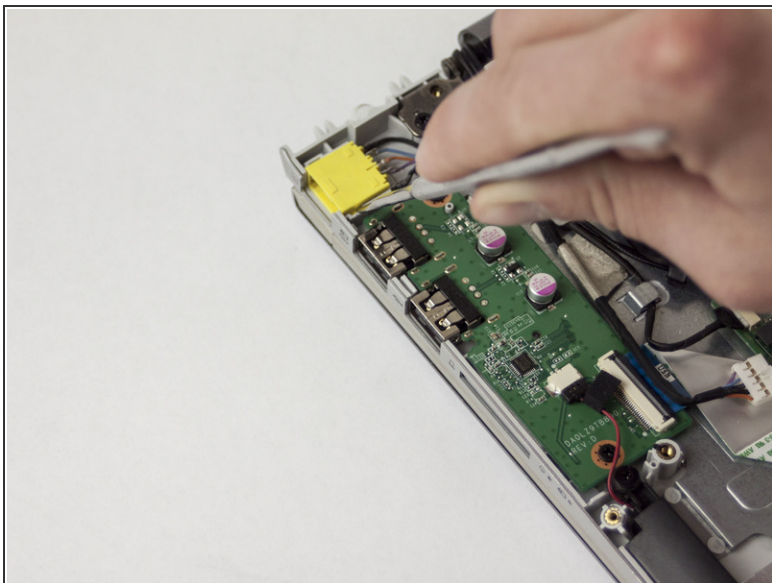
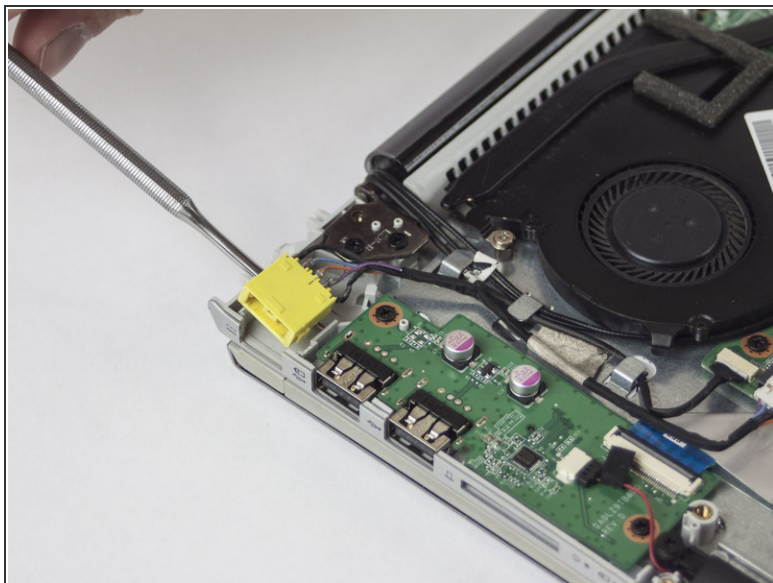
Step 5

- Pry the charging port out of the socket with a metal spudger.
- It may be necessary to pry from each side.

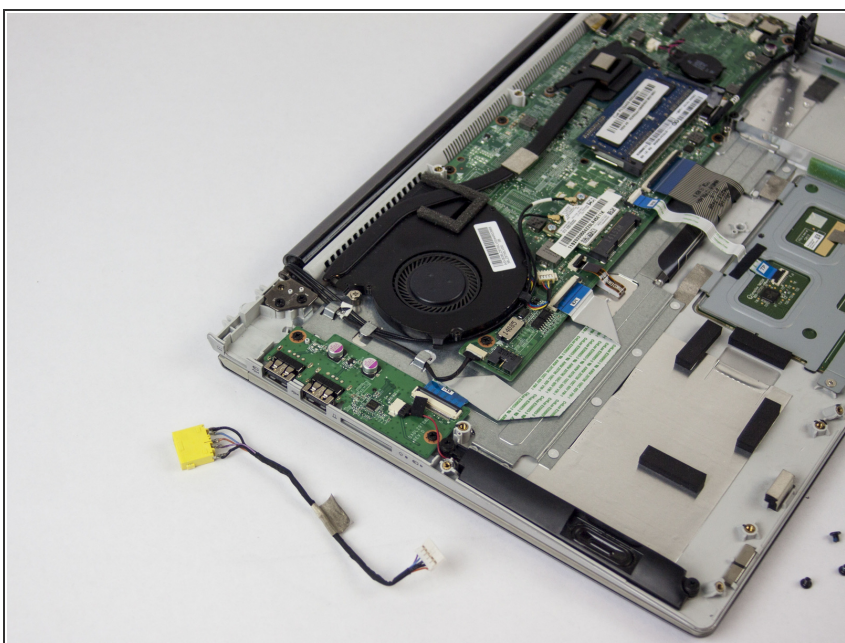
Step 6

- Remove charging port from laptop.
